# Manhole Inspection Summary

Manhole # S11II1010MH

Insp Date: **3/5/09 10:52 AM**

**Location** Address: **4600 REISTERSTOWN RD** Cross Street: **UMATILLA AVE**

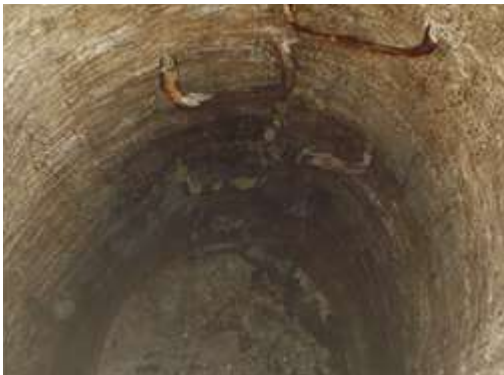
Defect 1

**Steps** Count: **11** Missing: **0** ☒ **Corroded**

Corroded step

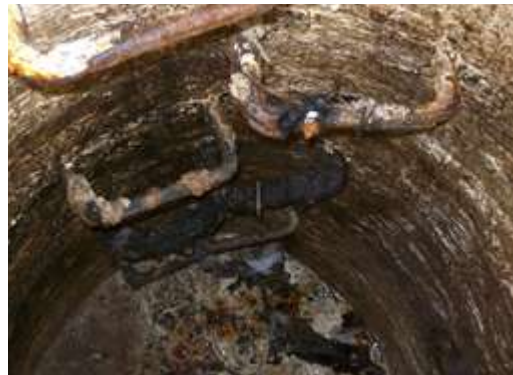
Defect 2

**Surcharge** ☒ **Evidence Of Surcharge** Depth: **7** (ft.) ☐ Active Surcharge Present

EVIDENCE OF SUCHARGE

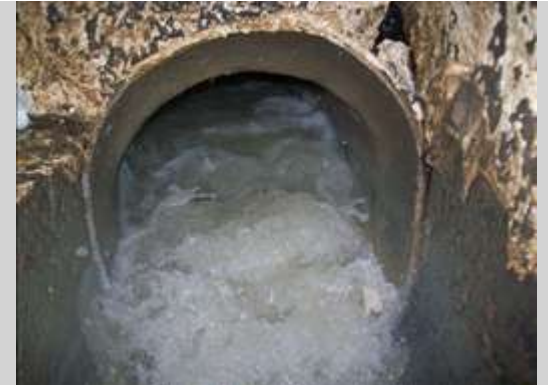
12 O'Clock Outflow

18 in. Circular Gravity Sewer  
Pipe Out @ 12 O'Clock

Invert Depth: **17.16** (ft.) Flow Characteristics: **Turbulent**

Deposits: ☒ None ☐ Mud ☐ Sludge ☐ Debris ☐ Grease

Infiltration: **None** Pipe Seal Cond: **Sound**

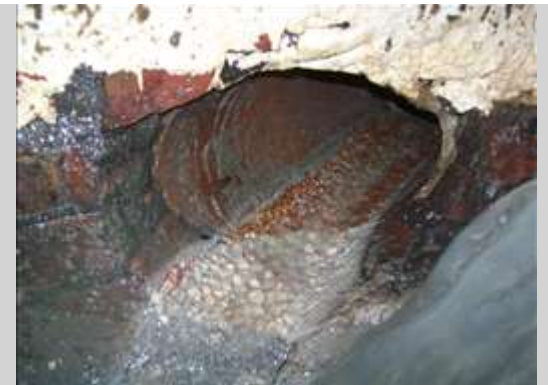
5 O'Clock Inflow

8 in. Circular Gravity Sewer  
Pipe In @ 5 O'Clock

Invert Depth: **16.30** (ft.) Flow Characteristics: **Slow**

Deposits: ☒ None ☐ Mud ☐ Sludge ☐ Debris ☐ Grease

Infiltration: **None** Pipe Seal Cond: **Sound**

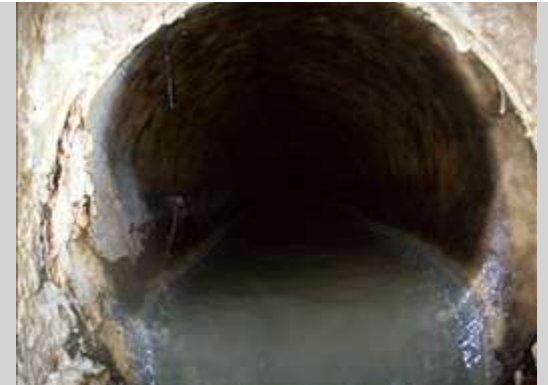
6 O'Clock Inflow

18 in. Circular Gravity Sewer  
Pipe In @ 6 O'Clock

Invert Depth: **15.50** (ft.) Flow Characteristics: **Fast**

Deposits: ☒ None ☐ Mud ☐ Sludge ☐ Debris ☐ Grease

Infiltration: **None** Pipe Seal Cond: **Sound**
